**Advanced Automated HVAC Fault  
Detection and Diagnostics  
Commercialization Program**

**Final Report on Field Demonstration of Air  
Handling Unit and Variable Air Volume Box  
Fault Detection Tools**

**CONSULTANT REPORT**

May 2006  
Contract #500-03-030  
Subtask 3.3d Deliverable

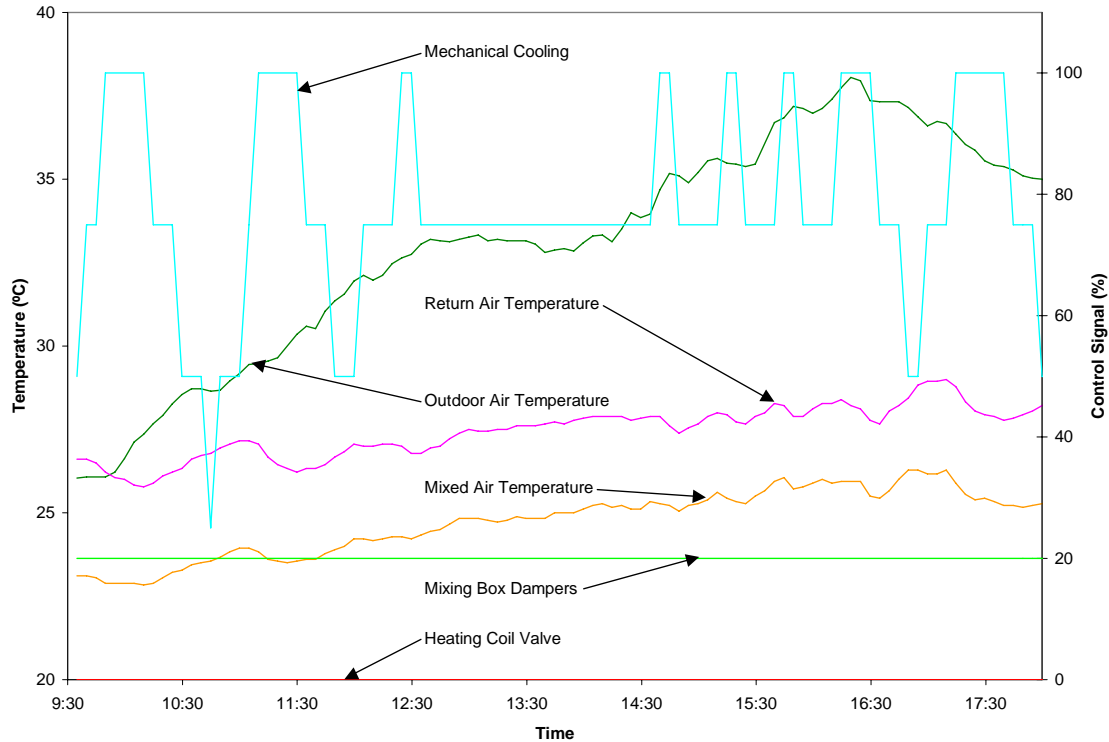
**Figure 5.1. SITE-1 Mixed Air Temperature Sensor Error.**

Figure 5.1 shows a plot of temperature and control signal data from one of the rooftop AHUs at SITE-1. The heating coil valve is fully closed and the mixing box dampers are positioned for the minimum outdoor air fraction needed to meet ventilation requirements (20 %). Stages of mechanical cooling are energized based on cooling requests from the terminal units served by the AHU. This combination of control signals corresponds to Mode 4: mechanical cooling with minimum outdoor air. In addition to the set of rules specific to Mode 4, there is a set of rules that applies to all occupied modes of operation (see Table 2.1). One rule which applies to all occupied modes is Rule 26, which states that the mixed air temperature should be greater than the minimum of the return and outdoor air temperatures. For nearly the entire time period shown in Figure 5.1, the return air temperature is less than the outdoor air temperature, so according to Rule 26, the mixed air temperature should be greater than the return air temperature. However, Figure 5.1 shows that the mixed air temperature is less than the return air temperature by approximately 3 °C. A trendlog showed that the APAR algorithm embedded in the AHU controller had generated a fault report due to Rule 26. As shown in Table 2.2, the possible causes of this fault are a return, mixed, or outdoor air temperature sensor error. Onsite personnel investigated, determined that the mixed air temperature sensor had drifted out of calibration, and recalibrated it.

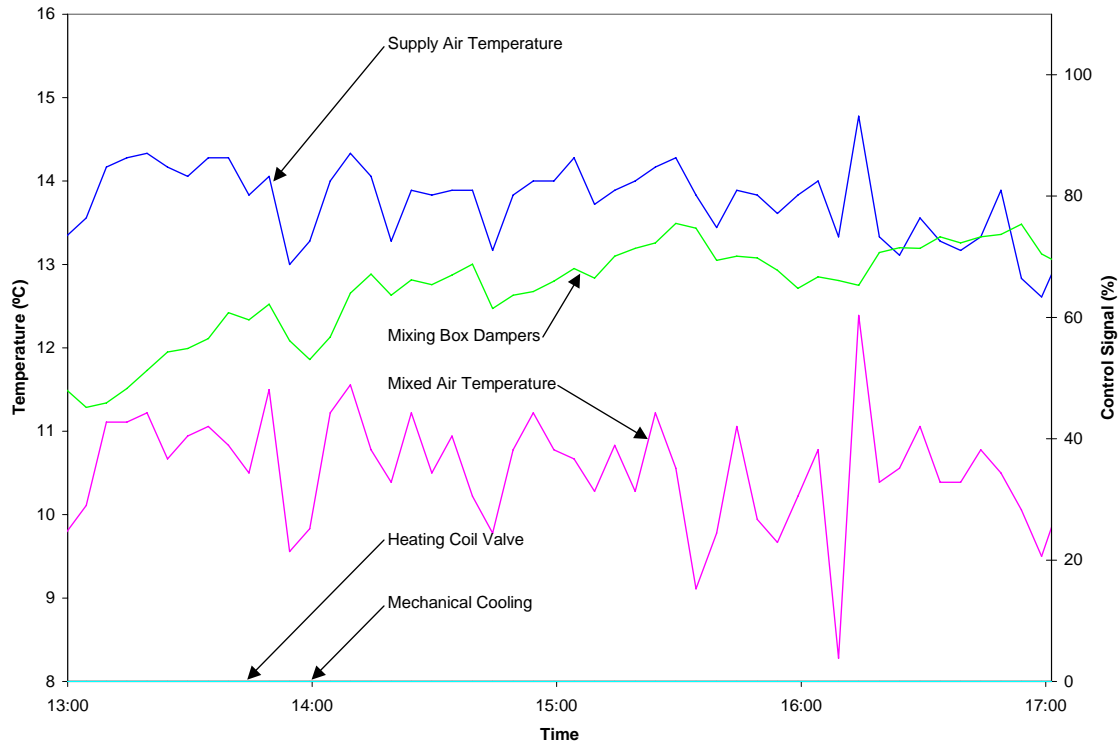
Figure 5.2. Leaking Heating Coil Valve.

Figure 5.2 shows a plot of temperature and control signal data from one of the rooftop AHUs at SITE-1. The heating coil valve is fully closed and all stages of mechanical cooling are de-energized. The mixing box dampers modulate to maintain the supply air temperature at its setpoint (not shown). This combination of control signals corresponds to Mode 2: cooling with outdoor air. One of the rules for Mode 2 is Rule 7, which states that the supply air and mixed air temperatures should be nearly the same. Figure 5.2 shows that the supply air temperature is greater than the mixed air temperature by approximately 3 °C. A trendlog showed that the APAR algorithm embedded in the AHU controller had generated a fault report due to Rule 7. As shown in Table 2.2, the possible causes of this fault are a supply or mixed air temperature sensor error, a problem with the mechanical cooling system (since chilled water is not used), or a stuck or leaking heating coil valve. Onsite personnel investigated and determined that there was a leak in the heating coil valve.

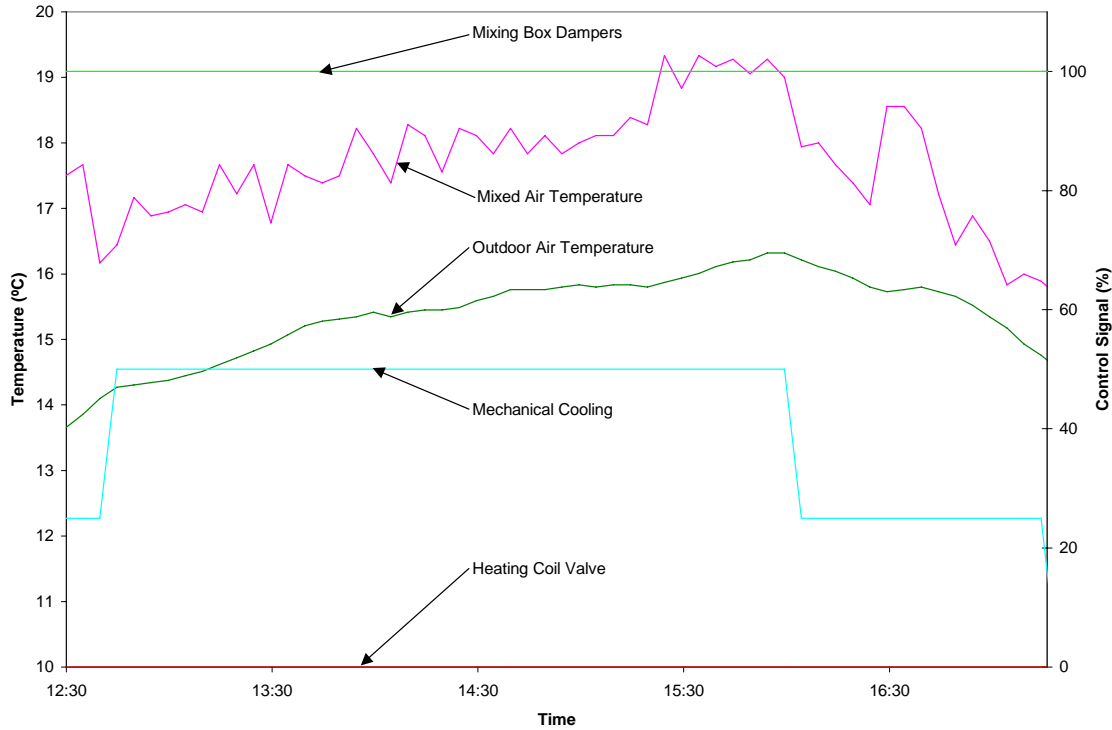
Figure 5.3. Outdoor Air Temperature Sensor Error.

Figure 5.3 shows a plot of temperature and control signal data from one of the rooftop AHUs at SITE-1. The heating coil valve is fully closed and the mixing box dampers are positioned for 100 % outdoor air. Stages of mechanical cooling are energized based on cooling requests from the terminal units served by the AHU. This combination of control signals corresponds to Mode 3: mechanical cooling with 100 % outdoor air. One of the rules for Mode 3 is Rule 10, which states that the outdoor air and mixed air temperatures should be nearly the same. Figure 5.3 shows that the mixed air temperature is greater than the outdoor air temperature by 2 to 3 °C. A trendlog showed that the APAR algorithm embedded in the AHU controller had generated a fault report due to Rule 10. As shown in Table 2.2, the possible causes of this fault are an outdoor or mixed air temperature sensor error or a stuck or leaking mixing box damper. Onsite personnel investigated and determined that the fault was due to an outdoor air temperature sensor error caused by a difference in temperature between the location of the outdoor air temperature sensor and the AHU's outdoor air intake.

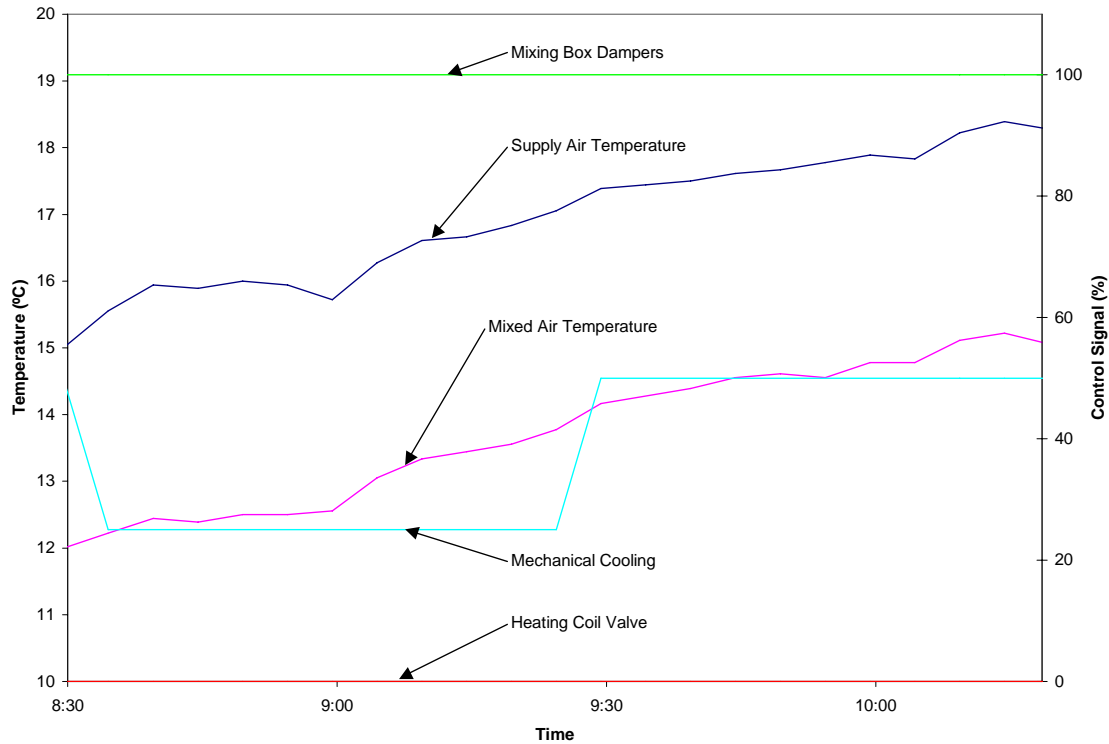
Figure 5.4. Mechanical Cooling Fault.

Figure 5.4 shows a plot of temperature and control signal data from one of the rooftop AHUs at SITE-1. The heating coil valve is fully closed and the mixing box dampers are positioned for 100 % outdoor air. Stages of mechanical cooling are energized based on cooling requests from the terminal units served by the AHU. This combination of control signals corresponds to Mode 3: mechanical cooling with 100 % outdoor air. One of the rules for Mode 3 is Rule 11, which states that the supply air temperature should be less than the mixed air temperature. Figure 5.4 shows that the supply air temperature is 3 to 4 °C greater than the mixed air temperature. A trendlog showed that the APAR algorithm embedded in the AHU controller had generated a fault report due to Rule 11. Table 2.2 lists the possible causes of this fault including a supply or mixed air temperature sensor error, a fouled or undersized heating or cooling coil, and problems associated with mechanical cooling system. Onsite personnel investigated, determined that the fault was due to a problem with the mechanical cooling system, and added it to a list of tasks that was prepared for a maintenance contractor.

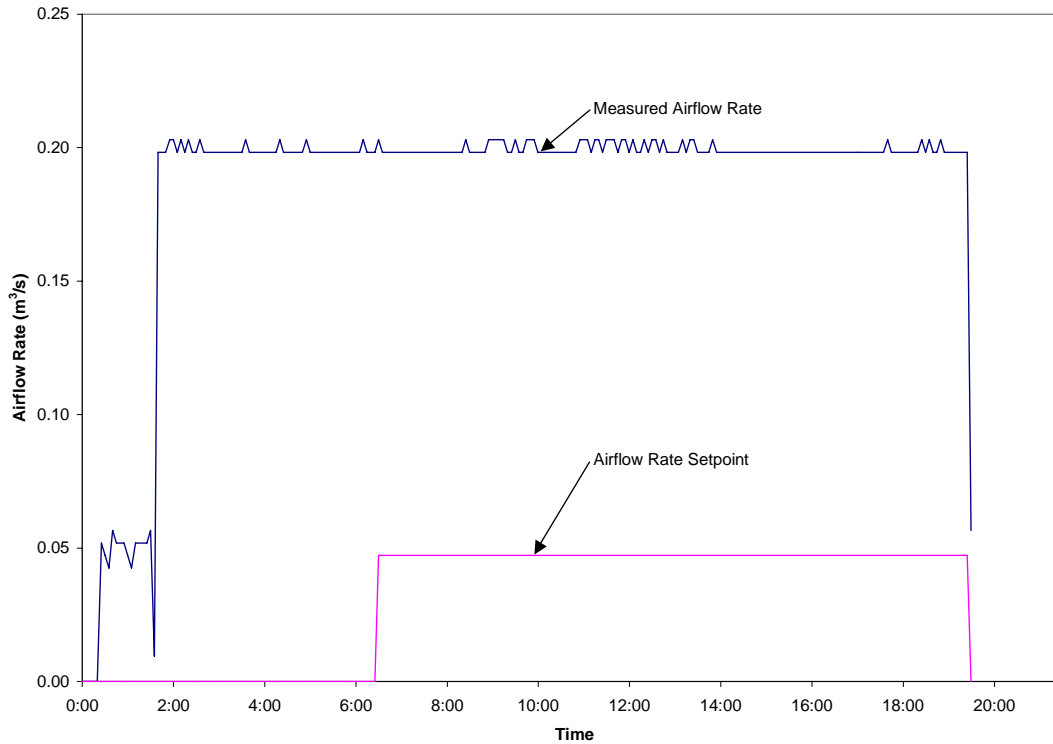
**Figure 5.5. Stuck VAV Box Damper Actuator.**

Figure 5.5 shows a plot of airflow data from one of the fan powered VAV boxes at SITE-1. The plot shows that there was a large positive airflow error, since the measured airflow rate was substantially greater than the airflow rate setpoint. A trendlog showed that the VPACC algorithm embedded in the VAV box controller reported a high airflow alarm. Table 2.3 lists the possible causes of this fault including an airflow (DP) sensor error, a stuck or failed damper or damper actuator, a scheduling conflict with the AHU, a tuning problem with the airflow control PID loop, and a sequencing logic error. Onsite personnel investigated and determined that the fault was due to a stuck damper actuator.

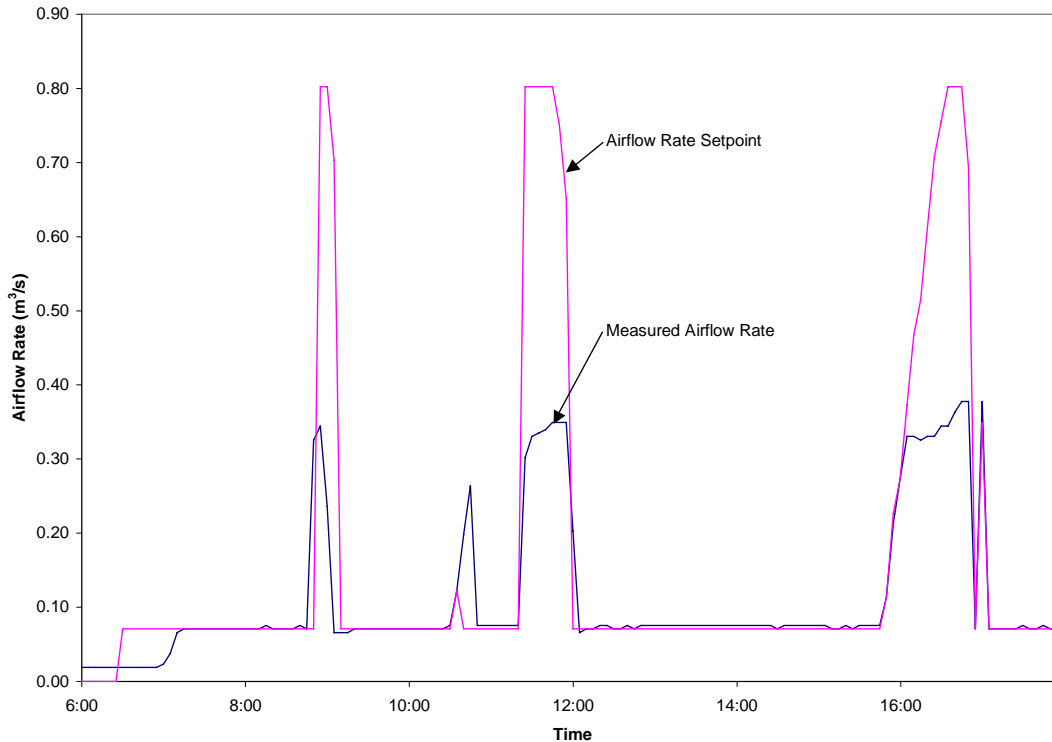
**Figure 5.6. VAV Box Airflow Parameter Error.**

Figure 5.6 shows a plot of airflow data from one of the fan powered VAV boxes at SITE-1. The plot that whenever the airflow setpoint increased above the minimum, there was a large negative airflow error, since the measured airflow rate was substantially less than the airflow rate setpoint. A trendlog showed that the VPACC algorithm embedded in the VAV box controller reported a low airflow alarm. Table 2.3 lists the possible causes of this fault, including an airflow (DP) sensor error, a stuck or failed damper or damper actuator, low static pressure in the supply air duct, a scheduling conflict with the AHU, an undersized VAV box, a tuning problem with the airflow control PID loop, a maximum airflow setpoint that is too high, and a sequencing logic error. Onsite personnel investigated and determined that the fault was due to a maximum airflow setpoint that was too high. The VAV box controller was originally installed on a larger VAV box. During a building renovation, the controller was moved to a smaller VAV box, but the maximum airflow parameter was not changed. As a result, even when the damper was fully open, the airflow rate never reached the nominal maximum value.

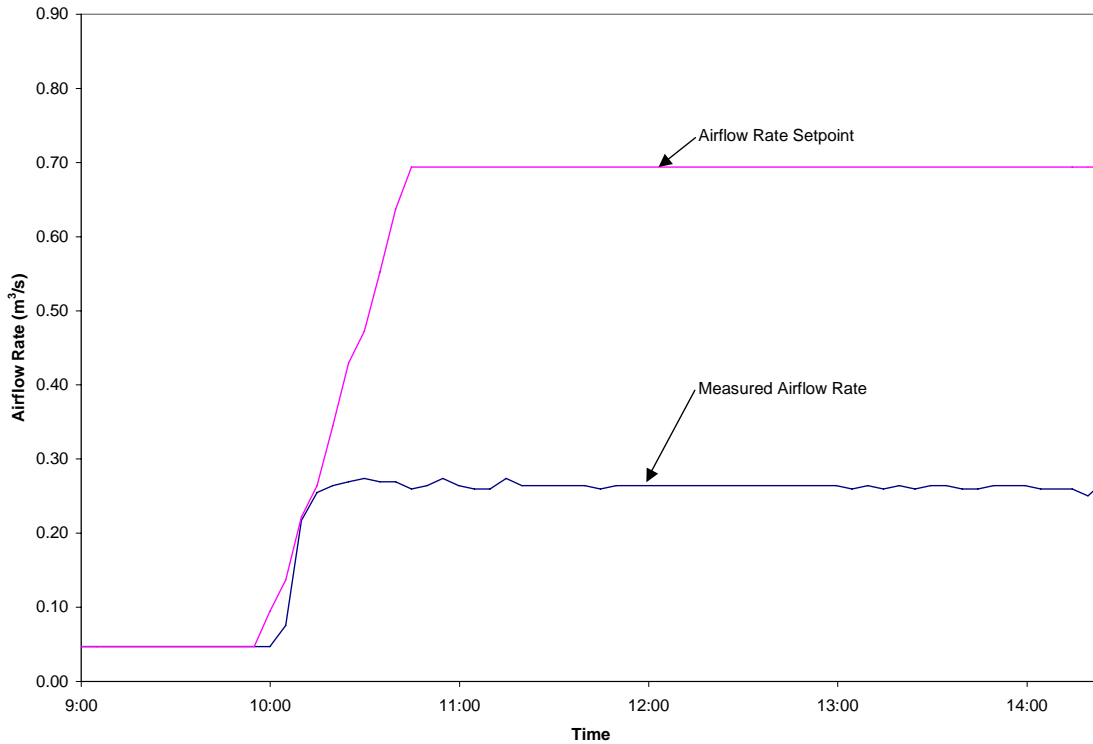
**Figure 5.7. Slipping Supply Fan Drive Belt.**

Figure 5.7 shows a plot of airflow data from one of the fan powered VAV boxes at SITE-1. The occupied period was from 0630 until 1930. During occupancy, the VAV box had a minimum airflow rate setpoint of  $0.047 \text{ m}^3/\text{s}$  to meet ventilation requirements. The plot shows that whenever the airflow setpoint increased above the minimum, there was a large negative airflow error, since the measured airflow rate was substantially less than the airflow rate setpoint. A trendlog showed that the VPACC algorithm embedded in the VAV box controller reported a low airflow alarm. Table 2.3 lists the possible causes of this fault, including an airflow (DP) sensor error, a stuck or failed damper or damper actuator, low static pressure in the supply air duct, a scheduling conflict with the AHU, an undersized VAV box, a tuning problem with the airflow control PID loop, a maximum airflow setpoint that is too high, and a sequencing logic error. Onsite personnel investigated and determined that the fault was due to low static pressure caused by a slipping supply fan drive belt in the AHU that serves this VAV box. Figure 5.7 illustrates that early in the day, the airflow rate setpoint was at the minimum and the supply fan was able to maintain sufficient static pressure. When the airflow setpoint increased later in the day, the actual airflow fell below the setpoint as the supply fan was not able to maintain the static pressure at the setpoint due to the slipping belt.

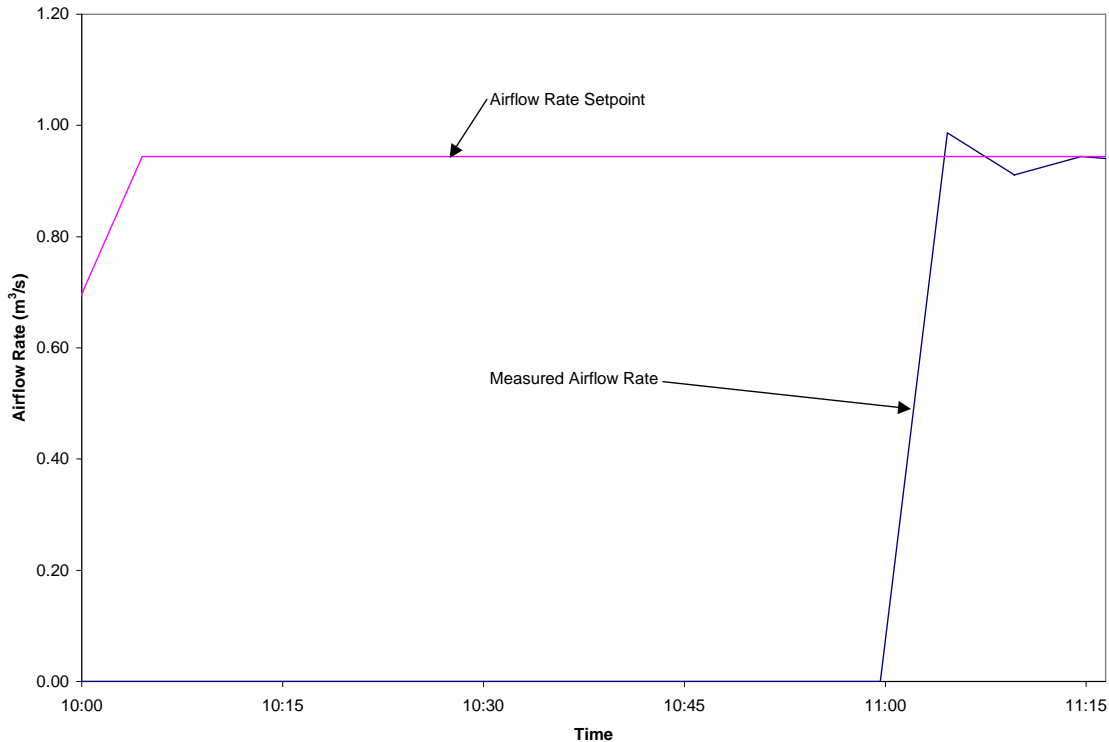
**Figure 5.8. Communication Failure.**

Figure 5.8 shows a plot of airflow data from one of the throttling (no fan) VAV boxes at SITE-1. It shows a large negative airflow error, since the measured airflow rate was substantially less than the airflow rate setpoint. A trendlog showed that the VPACC algorithm embedded in the VAV box controller reported a low airflow alarm. Table 2.3 lists the possible causes of this fault, including an airflow (DP) sensor error, a stuck or failed damper or damper actuator, low static pressure in the supply air duct, a scheduling conflict with the AHU, an undersized VAV box, a tuning problem with the airflow control PID loop, a maximum airflow setpoint that is too high, and a sequencing logic error. Onsite personnel investigated and determined that the fault was due to low static pressure caused by a temporary communication failure of the building control network. The AHUs at SITE-1 are scheduled based on the number of run requests received from the VAV boxes they serve. Since the AHU serving this VAV box did not receive any run requests, the supply fan was not energized and the static pressure in the supply air duct was too low. Figure 5.8 also shows that the fault disappeared when network communications were restored at approximately 11:00.

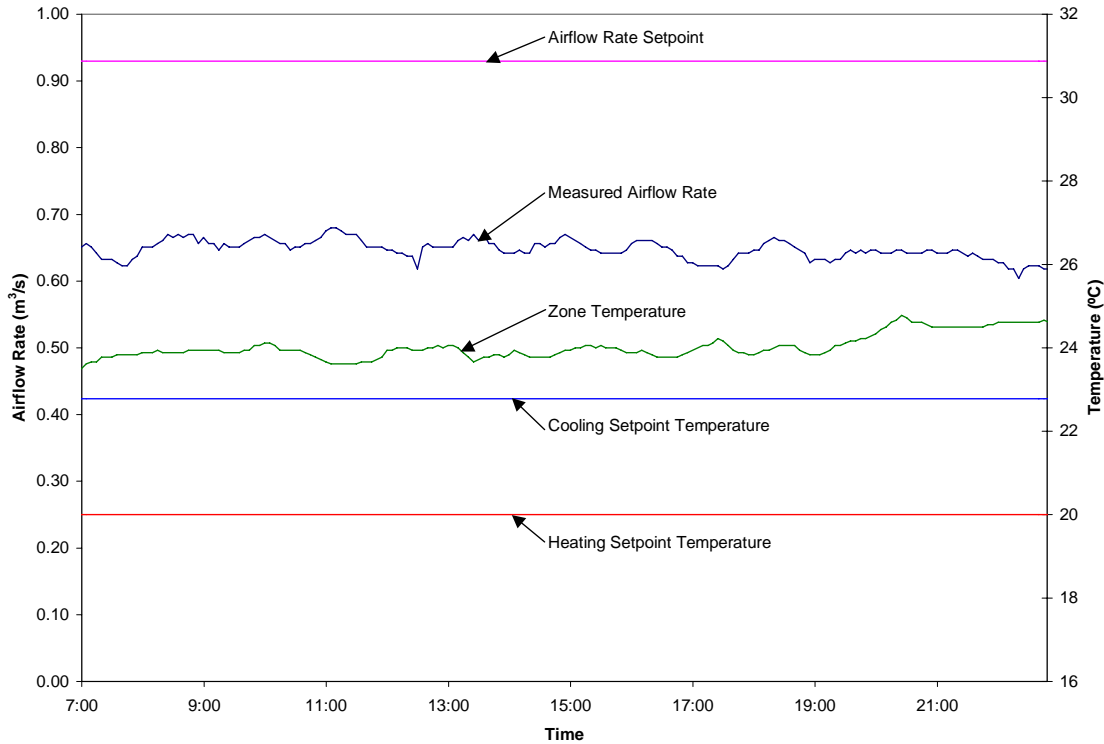
Figure 5.9. Undersized Supply Duct.

Figure 5.9 shows a plot of airflow and temperature data from one of the throttling (no fan) VAV boxes at SITE-1. It shows a large negative airflow error, since the measured airflow rate was substantially less than the airflow rate setpoint. There is also a large positive zone temperature error, since the zone temperature is greater than the cooling setpoint temperature. A trendlog showed that the VPACC algorithm embedded in the VAV box controller reported a low airflow alarm and a high zone temperature alarm. Table 2.3 lists the possible causes of this fault, including a zone temperature sensor error, an airflow (DP) sensor error, a stuck or failed damper or damper actuator, supply air too warm, low static pressure in the supply air duct, a scheduling conflict with the AHU, an undersized VAV box, a tuning problem with the airflow control or zone temperature control PID loop, a maximum airflow setpoint that is too low or too high, an inappropriate zone temperature setpoint, and a sequencing logic error. This VAV box does not have a reheat coil, so the possible causes of reheat coil valve or actuator stuck or failed shown in Table 2.3 do not apply. Onsite personnel investigated and determined that the fault was due to low static pressure in the supply duct. This is a large VAV box at the distant end of the supply duct from the serving AHU. The duct is undersized so under high load conditions this VAV box is starved of supply air. When this happens, the airflow rate drops below the airflow rate setpoint, and the zone temperature rises above the cooling setpoint temperature, since there is not enough airflow to meet the cooling load.

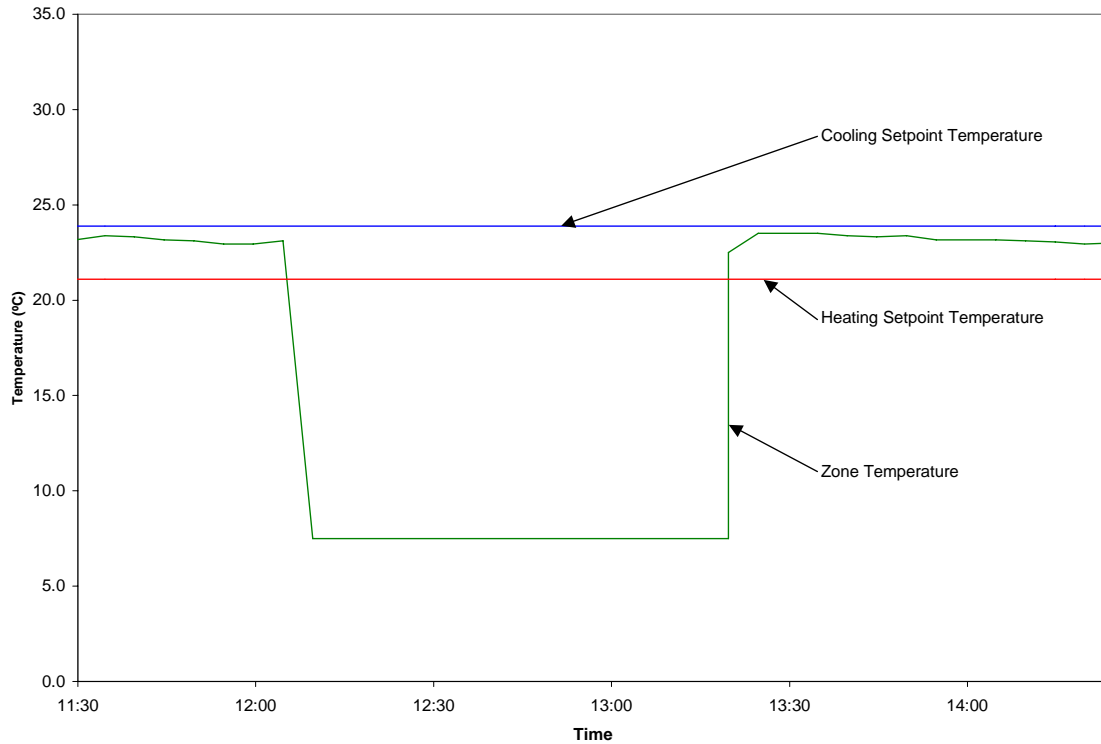
**Figure 5.10. Disconnected Zone Temperature Sensor.**

Figure 5.10 shows a plot of temperature data from one of the throttling (no fan) VAV boxes at SITE-1. It shows a large negative zone temperature error, since the zone temperature is less than the heating setpoint temperature. A trendlog showed that the VPACC algorithm embedded in the VAV box controller reported a low zone temperature alarm. Table 2.3 lists the possible causes of this fault, including a zone temperature sensor error, airflow (DP) sensor error, supply air too cool, a scheduling conflict with the AHU, an undersized VAV box, a tuning problem with the airflow control or zone temperature control PID loop, an inappropriate zone temperature setpoint, a minimum airflow setpoint that is too high, and a sequencing logic error. This VAV box does not have a reheat coil, so the possible causes of reheat coil valve or actuator stuck or failed shown in Table 2.3 do not apply. Onsite personnel investigated and determined that the fault was due to a zone temperature sensor error which occurred when the zone temperature sensor was inadvertently disconnected during maintenance. The sensor was configured for 0-10 V with a value of 7.5 °C at 0 V. When the sensor was disconnected, 0 V was read at the input on the VAV box controller, so a value of 7.5 °C was recorded, as shown in Figure 5.10. The figure also shows that the fault disappeared when the sensor was reconnected.

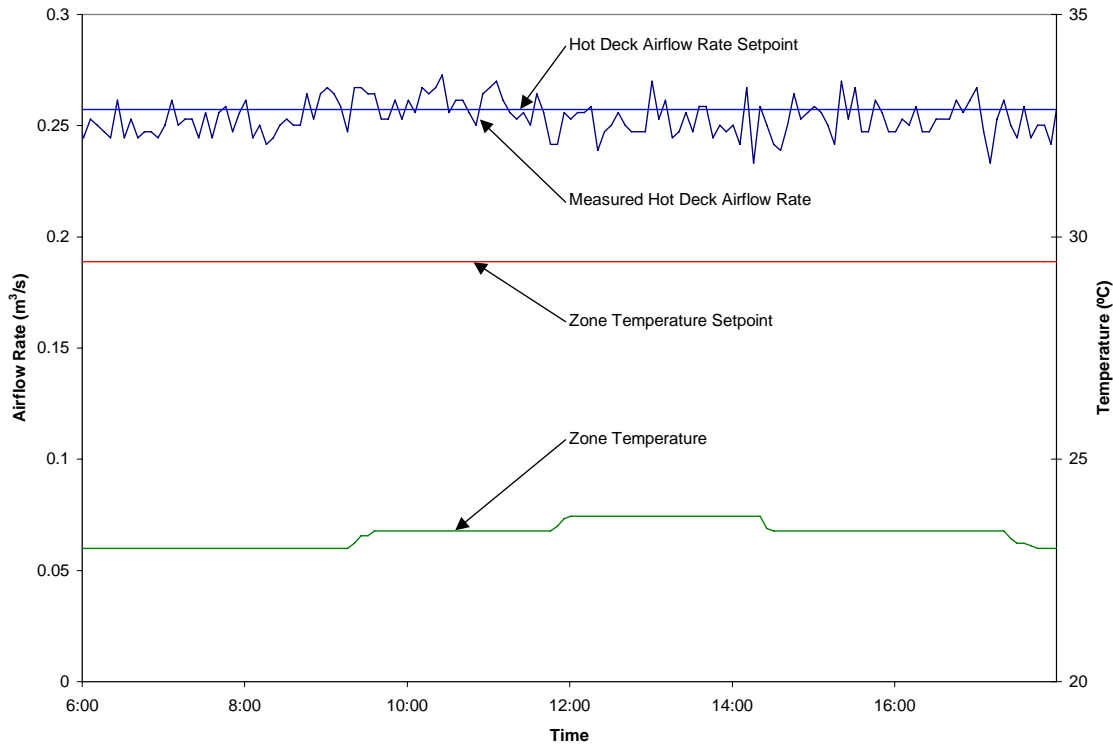
**Figure 5.11. Airflow (DP) Sensor Drift.**

Figure 5.11 shows a plot of airflow and temperature data from one of the dual-duct VAV boxes at SITE-2. It shows a large negative zone temperature error, since the zone temperature is less than the zone temperature setpoint. A trendlog showed that the VPACC algorithm embedded in the VAV box controller reported a low zone temperature alarm. Table 2.3 lists the possible causes of this fault, including a zone temperature sensor error, airflow (DP) sensor drift or failure, supply air too cool, a scheduling conflict with the AHU, an undersized VAV box, a tuning problem with the airflow control or zone temperature control PID loop, an inappropriate zone temperature setpoint, a minimum airflow setpoint that is too high, and a sequencing logic error. This VAV box does not have a reheat coil, so the possible causes of reheat coil valve or actuator stuck or failed shown in Table 2.3 do not apply. Onsite personnel investigated and determined that the fault was due to an airflow sensor error which occurred due to debris buildup in the tubing connecting the pressure probes in the hot deck inlet to the differential pressure sensor onboard the VAV box controller. Figure 5.11 shows that the measured hot deck airflow rate was at the setpoint, which was also the maximum hot deck airflow rate for the VAV box. However, the actual hot deck airflow rate was less than the measured value due to the sensor drift. Insufficient warm airflow was provided to the zone, causing the zone temperature to drift well below the setpoint. The fault was repaired by removing the debris from the tubing.

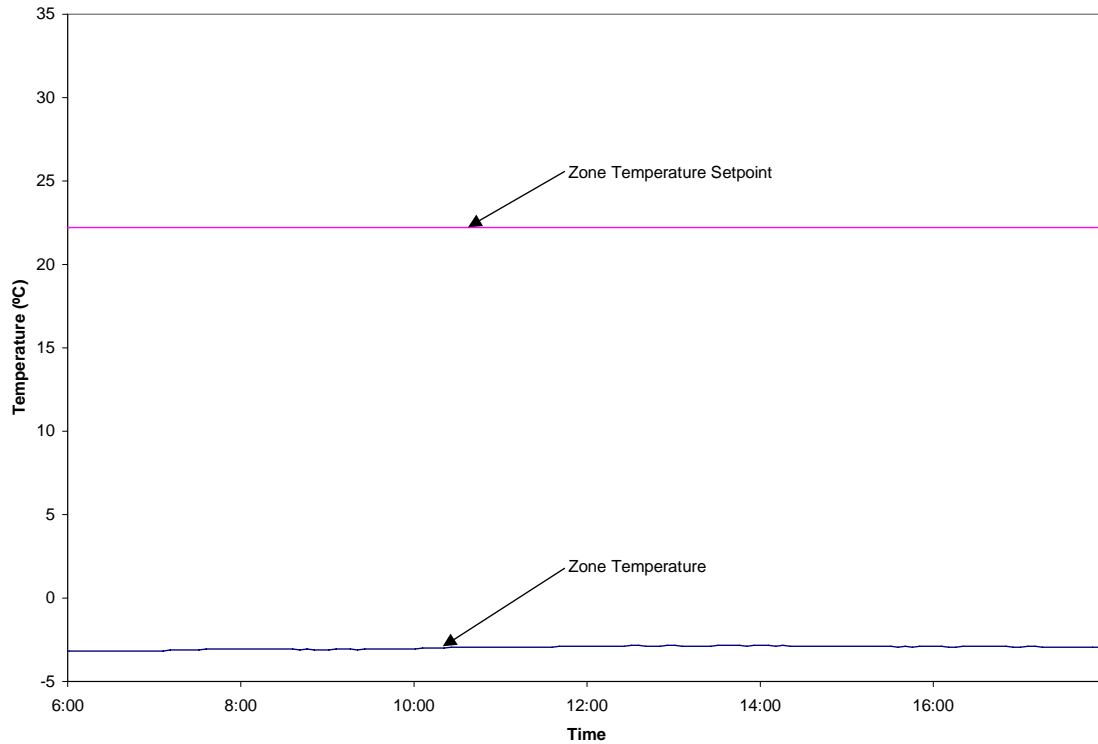
**Figure 5.12. Zone Temperature Sensor Failure.**

Figure 5.12 shows a plot of temperature data from one of the dual-duct VAV boxes at SITE-2. It shows a large negative zone temperature error, since the zone temperature is less than the zone temperature setpoint. A trendlog showed that the VPACC algorithm embedded in the VAV box controller reported a low zone temperature alarm. Table 2.3 lists the possible causes of this fault, including a zone temperature sensor error, airflow (DP) sensor drift or failure, supply air too cool, a scheduling conflict with the AHU, an undersized VAV box, a tuning problem with the airflow control or zone temperature control PID loop, an inappropriate zone temperature setpoint, a minimum airflow setpoint that is too high, and a sequencing logic error. This VAV box does not have a reheat coil, so the possible causes of reheat coil valve or actuator stuck or failed shown in Table 2.3 do not apply. Onsite personnel investigated and determined that the fault was due to a zone temperature sensor failure. The zone temperature shown in Figure 5.12 is close to the minimum of the range for the sensor, so this fault is not a complete failure, but an extreme sensor drift. The fault was repaired by replacing the sensor.

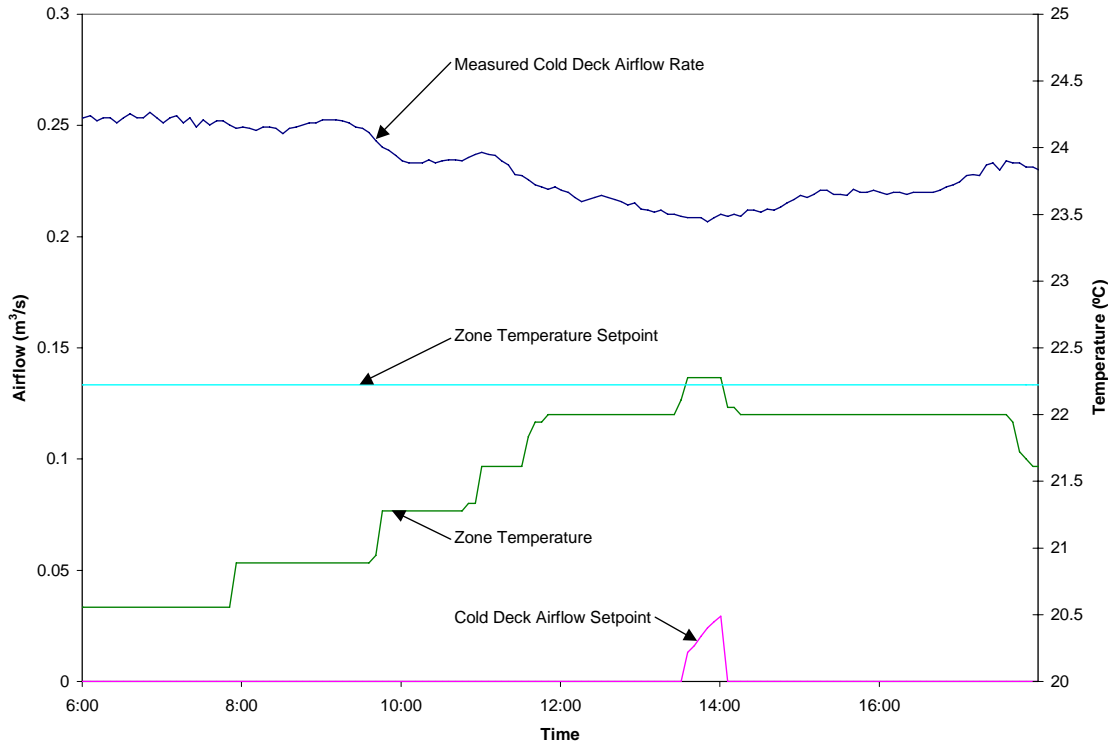
Figure 5.13. Damper Actuator Failure.

Figure 5.13 shows a plot of airflow and temperature data from one of the dual-duct VAV boxes at SITE-2. It shows a positive cold deck airflow rate error and a negative zone temperature error. A trendlog showed that the VPACC algorithm embedded in the VAV box controller reported a high cold deck airflow alarm and a low zone temperature alarm. Table 2.3 lists the possible causes of these faults, including a zone temperature sensor error, airflow (DP) sensor drift or failure, cold deck damper or actuator stuck or failed, supply air too cool, a scheduling conflict with the AHU, an undersized VAV box, a tuning problem with the airflow control or zone temperature control PID loop, an inappropriate zone temperature setpoint, a minimum airflow setpoint that is too high, and a sequencing logic error. This VAV box does not have a reheat coil, so the possible causes of reheat coil valve or actuator stuck or failed shown in Table 2.3 do not apply. Onsite personnel investigated and determined that the fault was due to a failed cold deck damper actuator. The damper failure allowed uncontrolled cold deck airflow to the zone, causing the zone temperature to fall well below the setpoint. The fault was repaired by replacing the broken actuator.

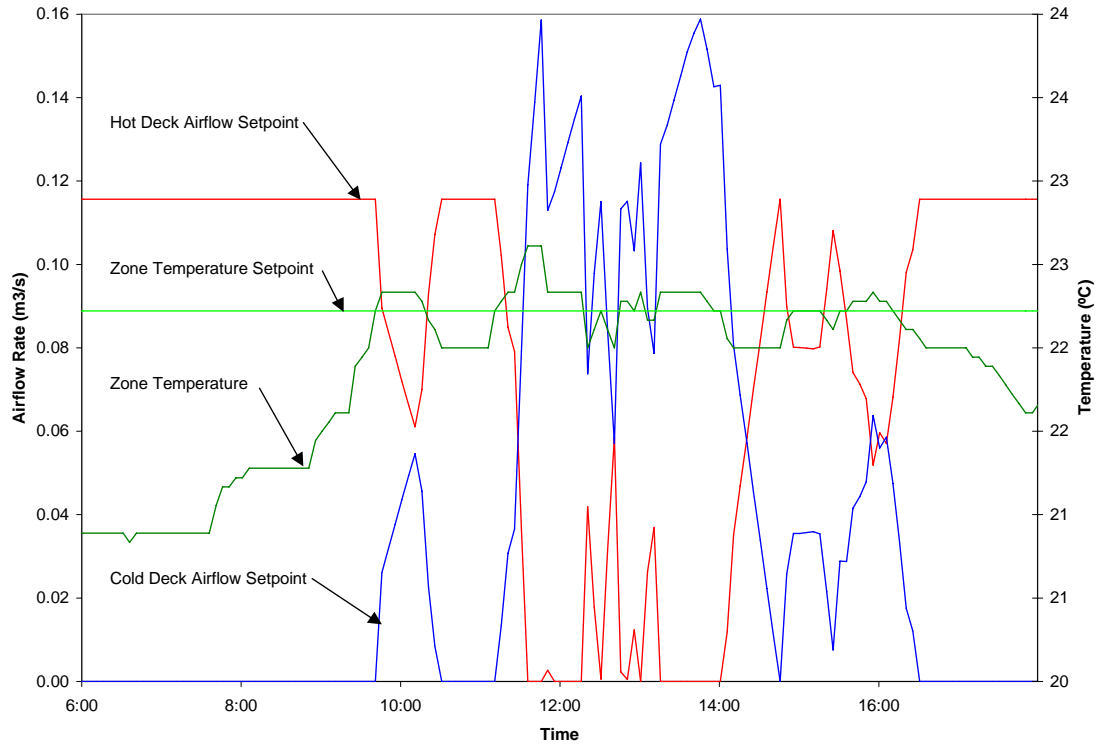
**Figure 5.14. Zone Temperature Control Loop Tuning Problem.**

Figure 5.14 shows a plot of airflow and temperature data from one of the dual-duct VAV boxes at SITE-2. It shows a negative zone temperature error, since the zone temperature is less than the zone temperature setpoint. A trendlog showed that the VPACC algorithm embedded in the VAV box controller reported a low zone temperature alarm. Table 2.3 lists the possible causes of this faults, including a zone temperature sensor error, airflow (DP) sensor drift or failure, supply air too cool, a scheduling conflict with the AHU, an undersized VAV box, a tuning problem with the airflow control or zone temperature control PID loop, an inappropriate zone temperature setpoint, a minimum airflow setpoint that is too high, and a sequencing logic error. This VAV box does not have a reheat coil, so the possible causes of reheat coil valve or actuator stuck or failed shown in Table 2.3 do not apply. Onsite personnel investigated and determined that the fault was due to an underdamped temperature control PID loop. The outputs of the zone temperature control loop are the hot and cold deck airflow setpoints. The hot and cold deck airflow control loops successfully maintained the hot and cold airflow rates (not shown) at their respective setpoints. Figure 5.14 shows that as the zone temperature approached the setpoint, the temperature control loop oscillated, as seen in the varying hot and cold deck airflow setpoints.

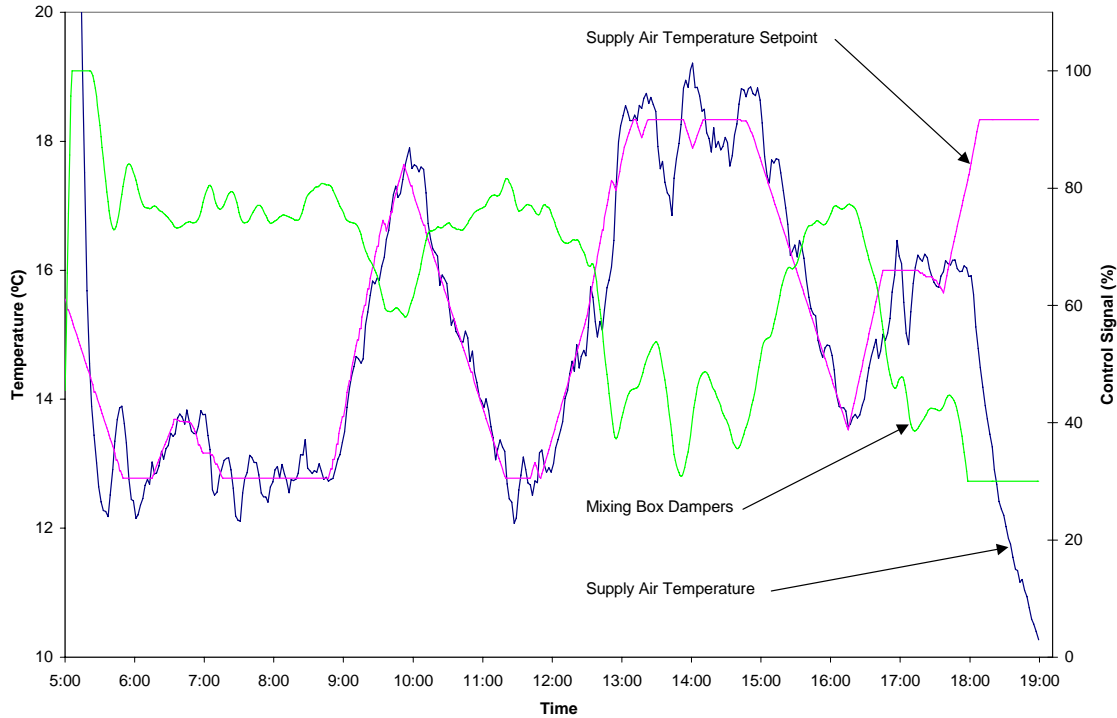
**Figure 5.15. SITE-3 Supply Air Temperature Error.**

Figure 5.15 shows a plot of temperature and control signal data from the AHU at SITE-3 for the occupied portion of one day. Both stages of heating (not shown) and all four stages of cooling (not shown) remain off while the mixing box dampers modulate to maintain the supply air temperature at its setpoint. This combination of control signals corresponds to Mode 2: cooling with outdoor air. In addition to the set of rules specific to Mode 4, there is a set of rules that apply to all occupied modes of operation (see Table 2.1). One rule which applies to all occupied modes is Rule 25, which states that the supply air temperature should be nearly equal to the supply air temperature setpoint. For most of the day shown, the supply air temperature is nearly equal to the setpoint, but from 17:45 until 19:00, the supply air temperature drifts well below the setpoint. A trendlog showed that the APAR algorithm embedded in the AHU controller had generated a fault report due to Rule 25 late in the day. As shown in Table 2.2, the only possible causes of this fault are either a controller tuning or logic error. Onsite personnel investigated and determined that the fault was not due to either of the possible causes listed by APAR. Instead it was the result of a low supply airflow rate due to a low cooling load. The constant toilet exhaust airflow rate caused the AHU outdoor air fraction to rise despite the mixing box dampers closing to the minimum position. It is unknown whether the AHU controller would have energized the first stage of heating had the condition persisted.

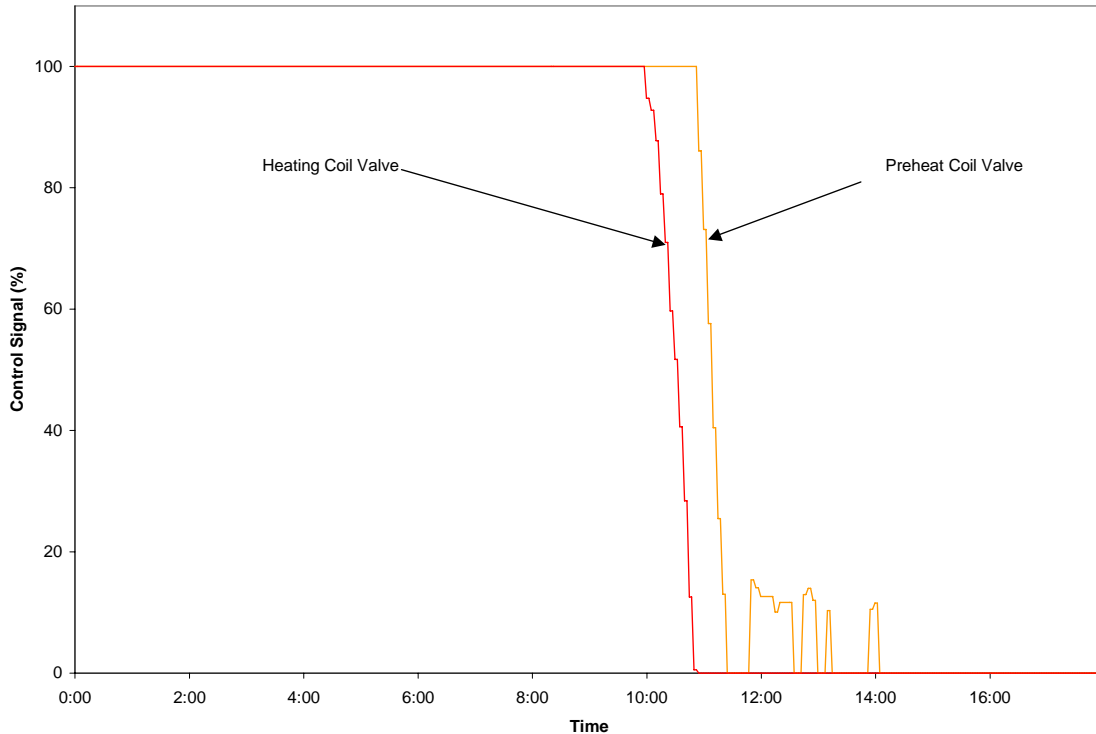
**Figure 5.16. SITE-4 Hot Water Converter Offline.**

Figure 5.16 shows a plot of control signal data from the AHU at SITE-4. This AHU has a preheat coil and a heating coil, which are sequenced in series to meet the heating load. Relatively small heating loads are met by opening the preheat coil valve only, while the heating coil valve remains closed. As the heating load increases, the preheat coil valve saturates open and the heating coil valve opens to meet the load. Figure 5.16 shows the AHU operating in Mode 1: heating. One of the rules for Mode 1 is Rule 4, which warns that the heating coil valve is saturated fully open. For the first 10 hours of the day shown, both the preheat and heating coil valves are saturated at 100 % open. A trendlog showed that the APAR algorithm embedded in the AHU controller had generated a fault report due to Rule 4. As shown in Table 2.2, the possible causes of this fault are either a supply air temperature sensor error, a stuck or leaking cooling coil valve, a stuck heating coil valve, an undersized heating coil, a fouled heating coil, hot water supply temperature too low, a problem with the hot water circulating pump, or a controller tuning error. Onsite personnel investigated and determined that the fault was due to a steam to hot water converter going offline. The converter supplies hot water to the preheat and heating coils of the AHU. When the converter was offline, the hot water supply temperature was too low. Figure 5.16 shows that the fault disappeared when the converter was brought back online at approximately 10:00.

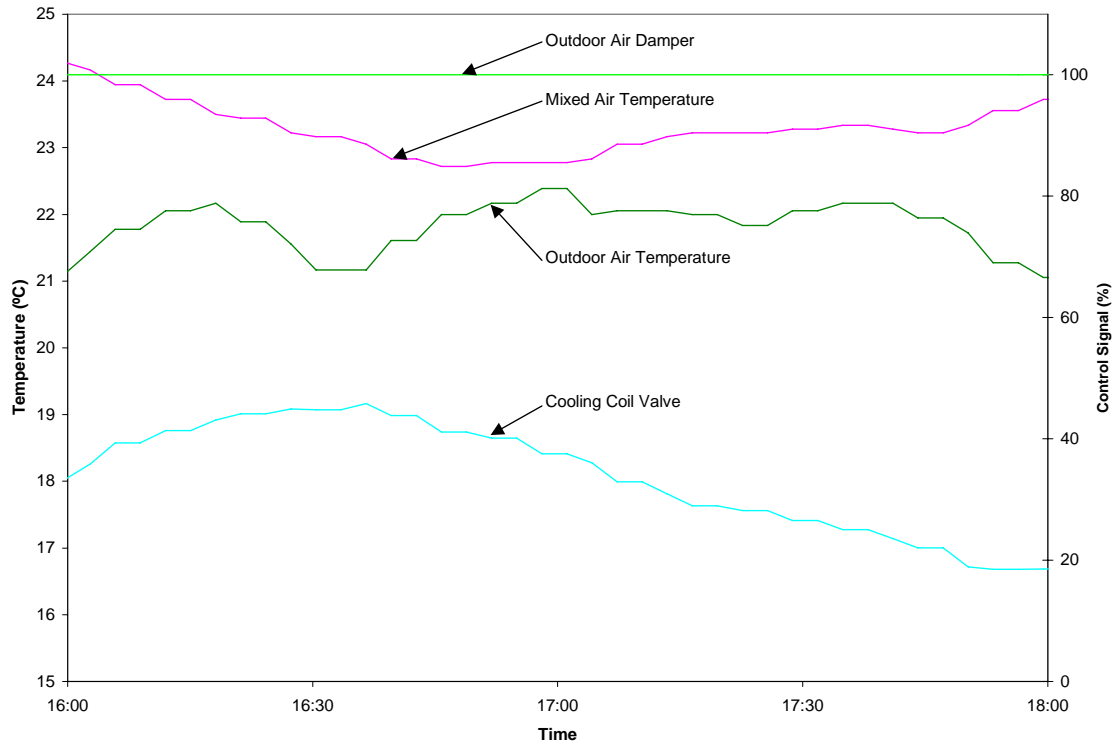
Figure 5.17. Manual Override of Outdoor Air Damper.

Figure 5.17 shows a plot of temperature and control signal data from the AHU at SITE-4. The preheat and heating coil valves (not shown) remain fully closed and the mixing box dampers are positioned for 100 % outdoor air. The cooling coil valve is modulated to meet the cooling load. This combination of control signals corresponds to Mode 3: mechanical cooling with 100 % outdoor air. One of the rules for Mode 3 is Rule 10, which states that the outdoor air and mixed air temperatures should be nearly the same. Figure 5.17 shows that the mixed air temperature is greater than the outdoor air temperature by as much as 3 °C. A trendlog showed that the APAR algorithm embedded in the AHU controller had generated a fault report due to Rule 10. As shown in Table 2.2, the possible causes of this fault are an outdoor or mixed air temperature sensor error or a stuck or leaking mixing box damper. Onsite personnel explained that the fault was due to a manual override of the outdoor air damper which had been made in response to a design flaw. The sequence of operations for this AHU specifies that the outdoor air damper open fully during occupied periods. However, under some weather conditions, the AHU does not have sufficient capacity to meet both the space heating/cooling load and the ventilation load. A manual override keeps the outdoor air damper partially closed, thereby reducing the ventilation load so that the AHU has sufficient capacity to maintain the space temperature and humidity at setpoint.

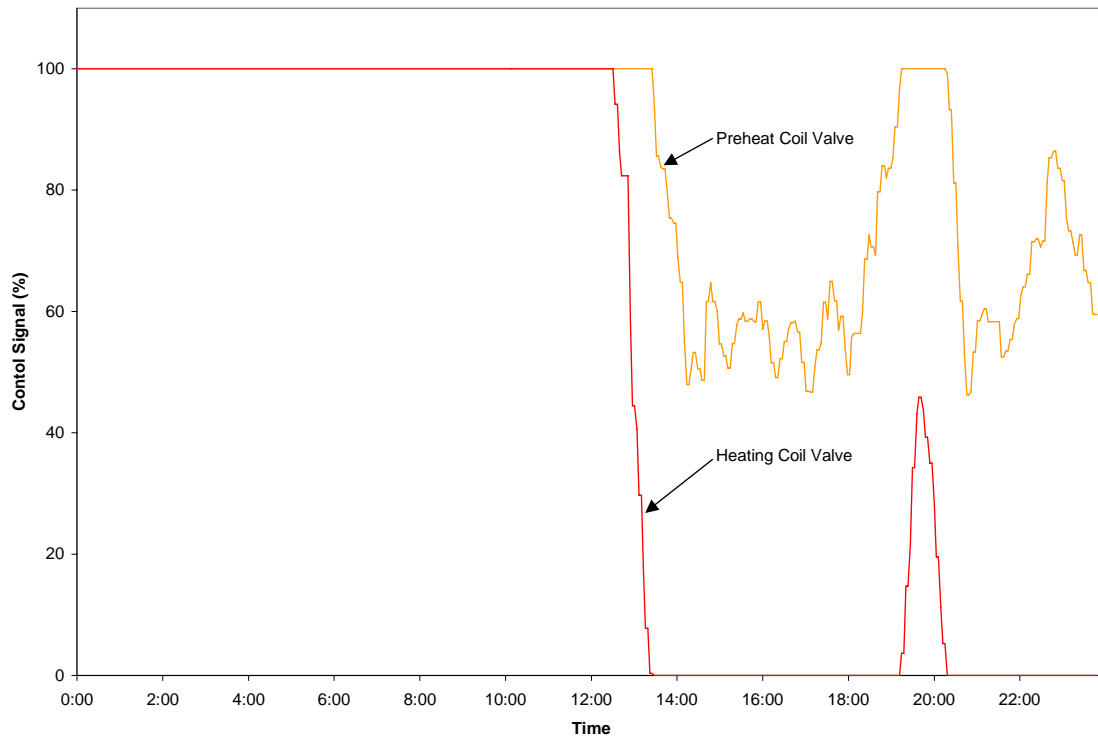
**Figure 5.18. Sitewide Steam Outage.**

Figure 5.18 shows a plot of temperature and control signal data from the AHU at SITE-4. This AHU has a preheat coil and a heating coil, which are sequenced as described in Section 5.4.1. Figure 5.18 shows the AHU operating in Mode 1: heating. One of the rules for Mode 1 is Rule 4, which warns that the heating coil valve is saturated fully open. For the first 12 hours of the day shown, both the preheat and heating coil valves are saturated at 100 % open. A trendlog showed that the APAR algorithm embedded in the AHU controller had generated a fault report due to Rule 4. As shown in Table 2.2, the possible causes of this fault are either a supply air temperature sensor error, a stuck or leaking cooling coil valve, a stuck heating coil valve, an undersized heating coil, a fouled heating coil, hot water supply temperature too low, a problem with the hot water circulating pump, or a controller tuning error. Onsite personnel investigated and determined that the fault was due to a sitewide steam outage which caused the hot water supply temperature to fall too low. Figure 5.18 shows that the fault disappeared when the steam supply was brought back online at approximately 12:00.
