**Advanced Automated HVAC Fault  
Detection and Diagnostics  
Commercialization Program**

**Final Report on Field Demonstration of Air  
Handling Unit and Variable Air Volume Box  
Fault Detection Tools**

**CONSULTANT REPORT**

May 2006  
Contract #500-03-030  
Subtask 3.3d Deliverable

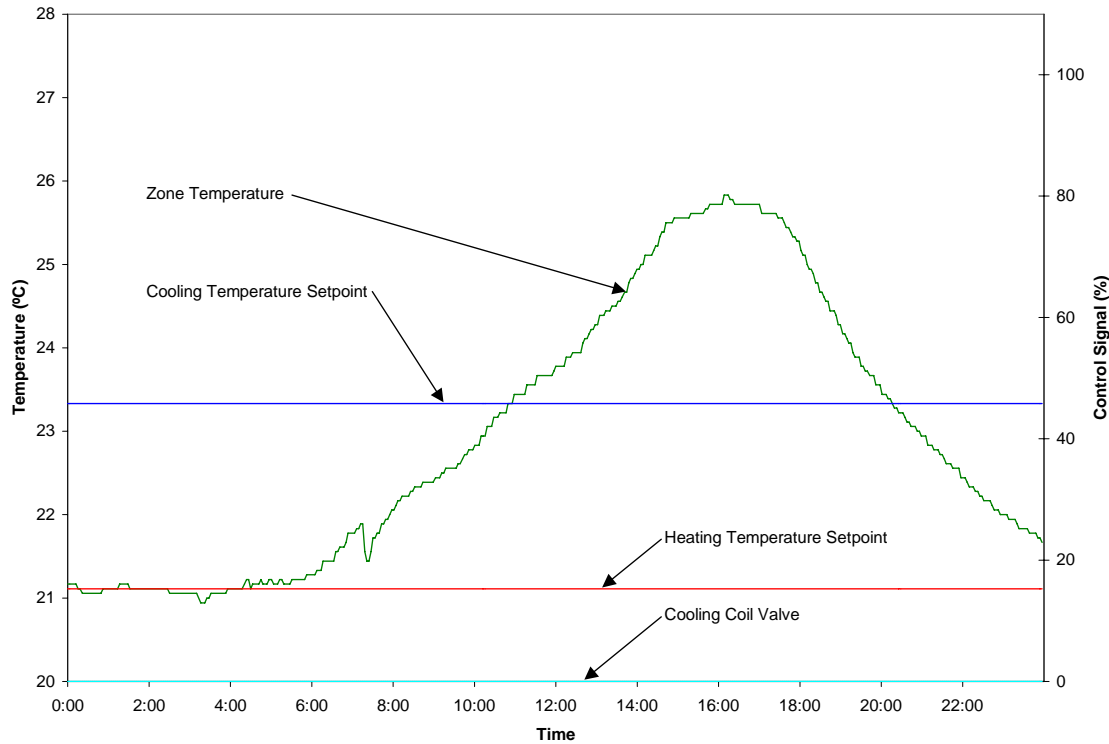
**Figure 5.19. Incorrect Cooling Coil Valve Actuator Configuration.**

Figure 5.19 shows a plot of temperature and control signal data from the AHU at SITE-4. It shows the AHU operating in Mode 5: unknown mode of operation. One of the rules which applies to all modes of operation is Rule 25, which states that the supply air temperature should be nearly equal to the supply air temperature setpoint. The sequence of operations for this single-zone AHU modulates the cooling coil valve to maintain the zone temperature between the heating and cooling setpoints, so Rule 25 was rewritten to state that the zone temperature should be between the cooling and heating setpoints. Figure 5.19 shows that the zone temperature exceeded the cooling setpoint by as much as 5.5 °C, yet the cooling coil valve remained closed. A trendlog showed that the APAR algorithm embedded in the AHU controller had generated a fault report due to Rule 25. As shown in Table 2.2, the possible causes of this fault are either a controller tuning or logic error. Onsite personnel investigated and determined that the fault was due to an incorrect configuration of the AHU controller output to the cooling coil valve actuator. The controller output was configured for 0 – 10 V, but the actuator was 2 – 10 V. As a result, the valve remained closed for controller output values from 0 – 2 V. The fault was repaired by reconfiguring the controller output for 2 – 10 V.

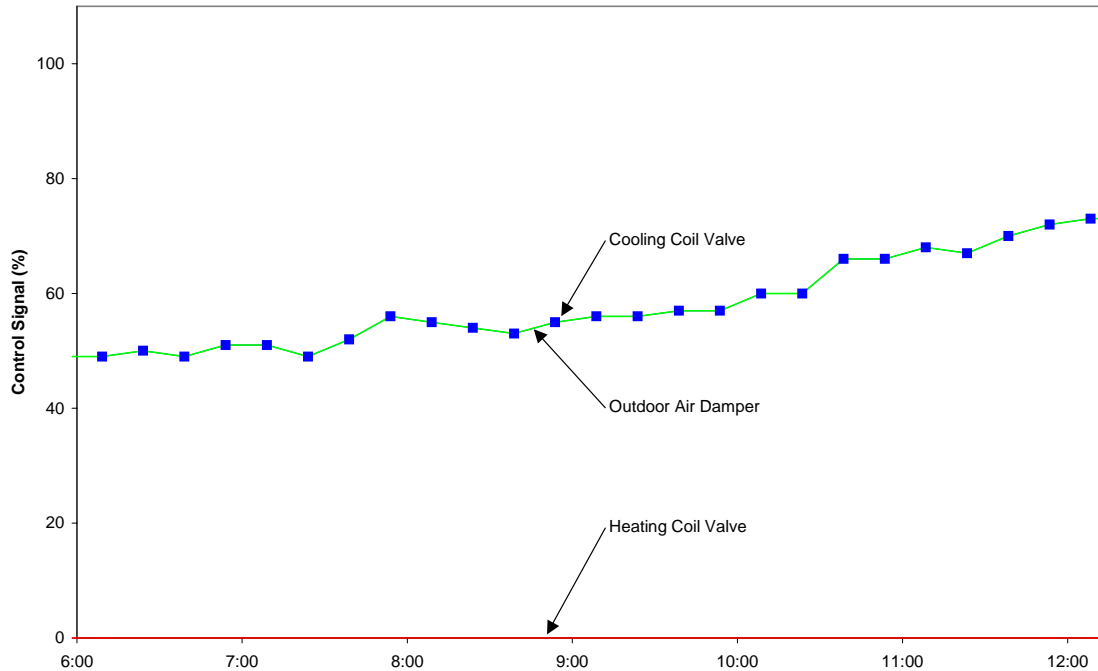
**Figure 5.20. SITE-5 Simultaneous Mechanical Cooling and Economizing.**

Figure 5.20 shows a plot of control signal data from one of the AHUs at SITE-5; it shows the AHU operating in Mode 5: unknown mode of operation. One of the rules for Mode 5 is Rule 24, which states that the AHU is simultaneously modulating the cooling coil valve and the economizer. As shown in Figure 5.20, the cooling coil valve and outdoor air damper move in concert from 50% to 75% open over the course of the morning. A trendlog showed that the APAR algorithm embedded in the AHU controller had generated a fault report due to Rule 24. As shown in Table 2.2, the possible causes of this fault are a controller tuning or logic (sequencing and scheduling) error. Since this fault was reported for both AHUs at SITE-5, a logic error was the most likely explanation. A review of the control logic revealed that the output of the temperature control PID loop was sent to both outputs simultaneously, which caused a greater load on the chiller and increased chiller run time, both contributing to increased energy consumption. Proper sequencing for conditions that meet the criteria for economizer operation would position the outdoor air damper to maintain the supply air temperature at its setpoint while keeping the cooling coil valve closed, thus meeting the cooling load without using mechanical cooling. If the cooling load is too great, the outdoor air damper will saturate at 100% open, and the cooling coil valve will open to maintain the supply air temperature at its setpoint. By keeping the outdoor air damper fully open, the load on the cooling coil will be minimized.

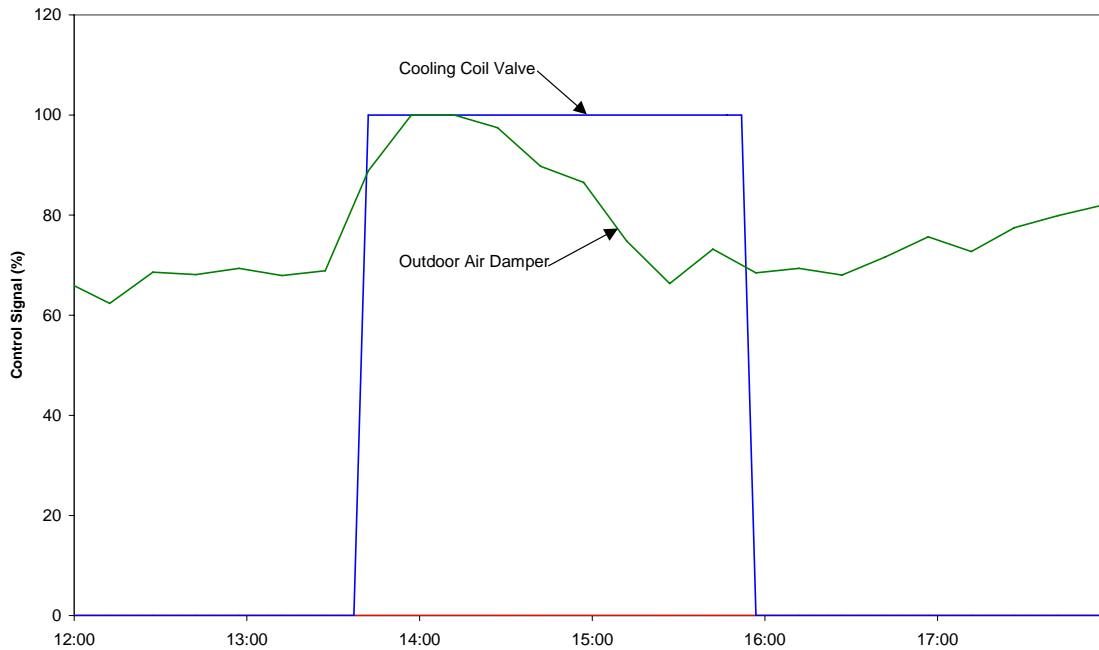
**Figure 5.21. SITE-6 Simultaneous Mechanical Cooling and Economizing.**

Figure 5.21 shows a plot of control signal data from one of the AHUs at SITE-6; it shows the AHU operating in Mode 5: unknown mode of operation. One of the rules for Mode 5 is Rule 24, which states that the AHU is simultaneously modulating the cooling coil valve and economizer. As shown in Figure 5.21, the cooling coil valve opens while the outdoor air damper is modulating. A trendlog showed that the APAR algorithm embedded in the AHU controller had generated a fault report due to Rule 24. As shown in Table 2.2, the possible causes of this fault are a controller tuning or logic (sequencing and scheduling) error. As in the simultaneous cooling and economizing fault for SITE-5, the AHU sequencing logic was the cause. In this case, two separate PID loops were used to position the cooling coil valve and the outdoor air damper. No interlocks or other logic was present to coordinate outdoor air damper operation with the heating and cooling coil valves.

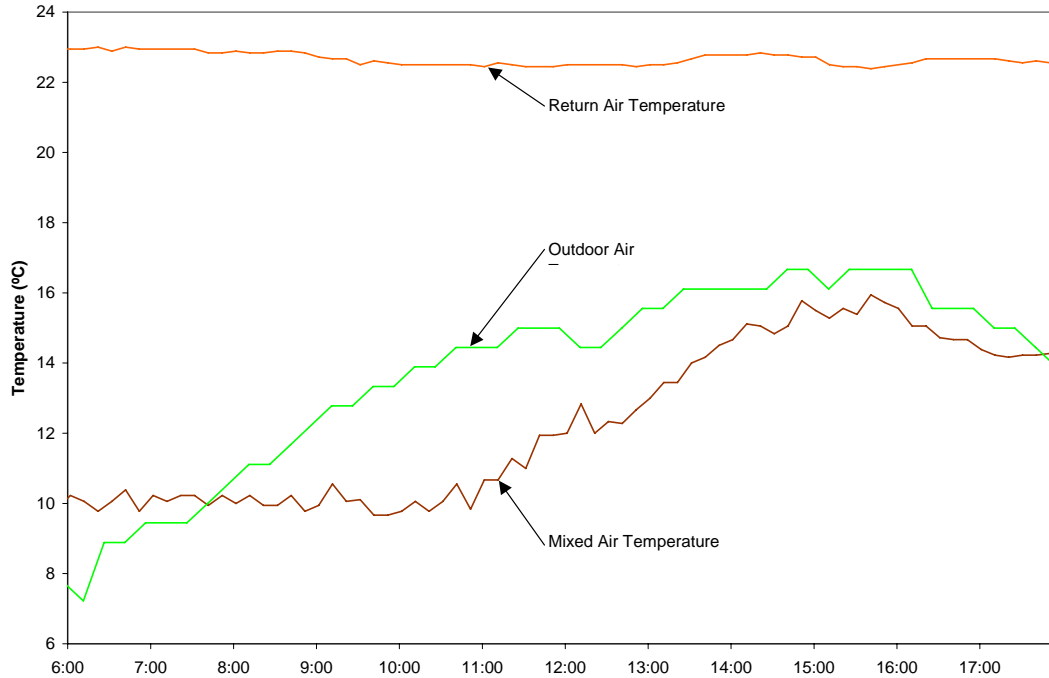
**Figure 5.22. SITE-6 Outdoor Air Temperature Sensor Error.**

Figure 5.22 shows a plot of temperature data from one of the AHUs at SITE-6. Rules 26 and 27 apply to all modes of operation and state that the mixed air temperature should be between the outdoor air and return air temperatures. Rule 26 checks whether the mixed air temperature is greater than the maximum of the outdoor air and return air temperatures, while Rule 27 checks whether the mixed air temperature is less than the minimum of the outdoor air and return air temperatures. Figure 5.22 shows that the mixed air temperature is less than the minimum of the outdoor air and return air temperatures by as much as 5 °C. A trendlog showed that the APAR algorithm embedded in the AHU controller had generated a fault report due to Rule 27. As shown in Table 2.2, the possible causes of this fault are an outdoor or mixed air temperature sensor error or a stuck or leaking mixing box damper. Onsite personnel investigated and determined that the fault was due to an outdoor air temperature sensor error caused by a difference in temperature between the location of the outdoor air temperature sensor and the AHU's outdoor air intake.

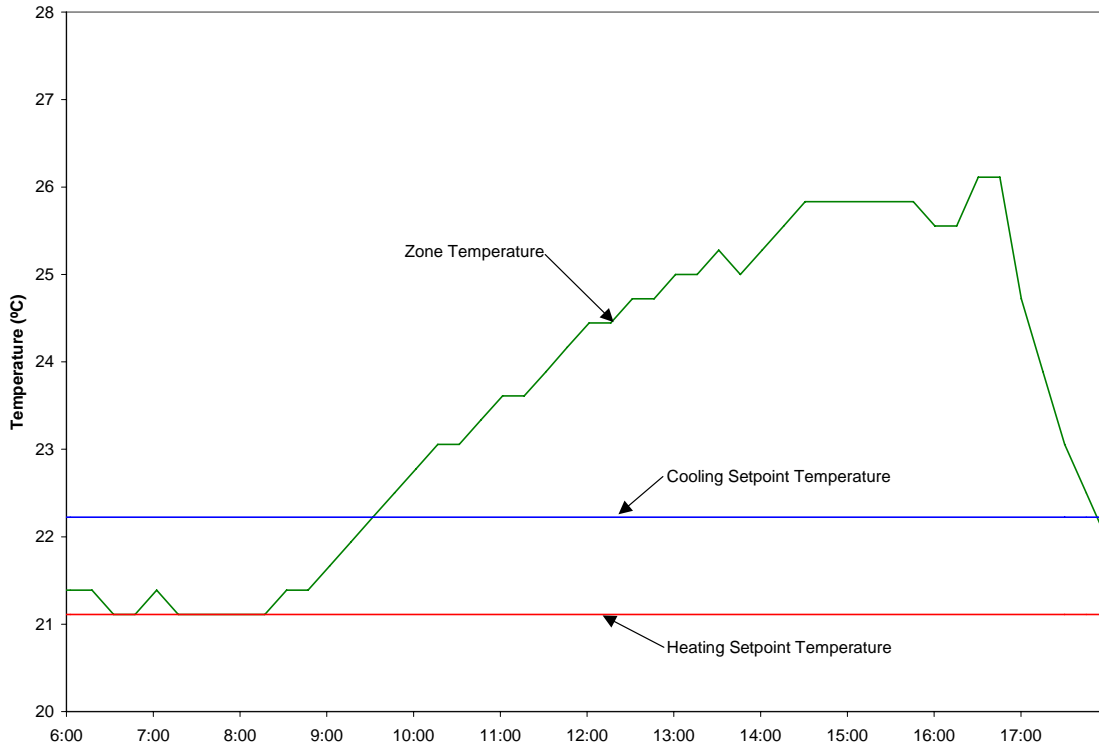
**Figure 5.23. SITE-6 Undersized VAV Box.**

Figure 5.23 shows a plot of temperature data from one of the VAV boxes at SITE-6. It shows a large positive zone temperature error, since the zone temperature is greater than the cooling setpoint temperature. A trendlog showed that the VPACC algorithm embedded in the VAV box controller reported a high zone temperature alarm. Table 2.3 lists the possible causes of this fault, including a zone temperature sensor error, airflow (DP) sensor error, reheat coil valve or actuator stuck or failed, supply air too warm, a scheduling conflict with the AHU, an undersized VAV box, a tuning problem with the airflow control or zone temperature control PID loop, an inappropriate zone temperature setpoint, a maximum airflow setpoint that is too low, and a sequencing logic error. Onsite personnel investigated and determined that the fault was due to a high solar heat gain to the conditioned space, which is a lobby with large windows. The VAV box is not large enough to provide a sufficient supply airflow rate to meet the load.

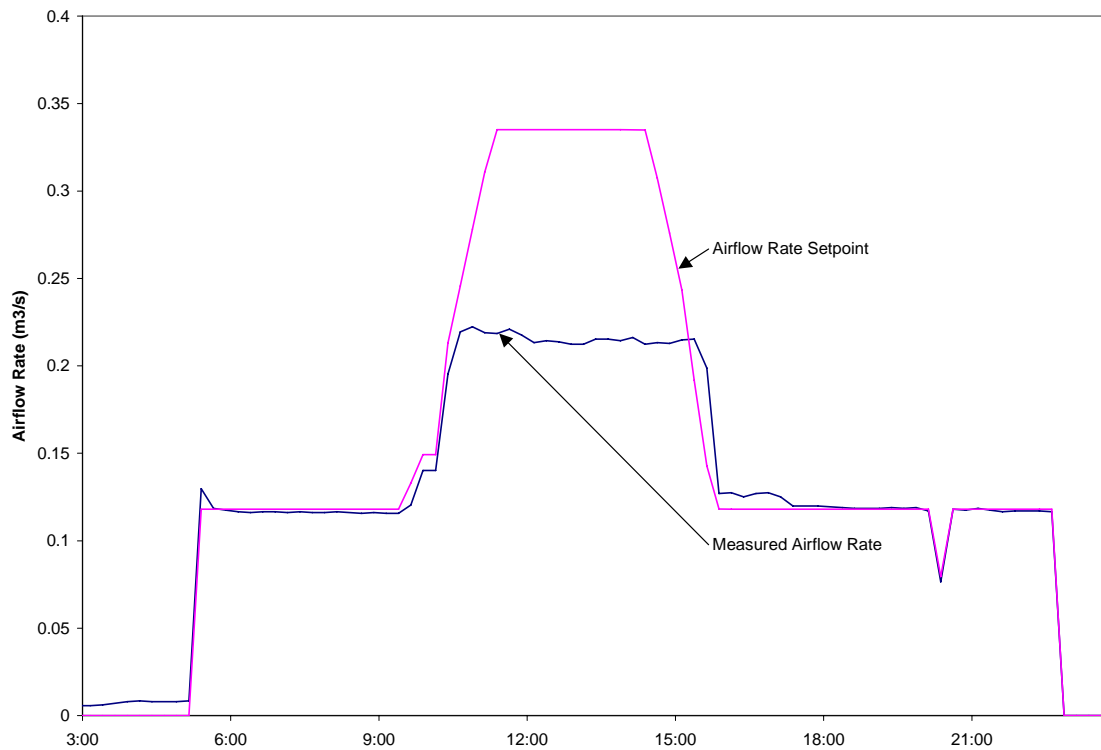
**Figure 5.24 SITE-6 Undersized Supply Fan.**

Figure 5.24 shows a plot of airflow data from one of the VAV boxes at SITE-6. The plot shows that the measured airflow rate was substantially less than the airflow rate setpoint. A trendlog showed that the VPACC algorithm embedded in the VAV box controller reported a low airflow alarm. Table 2.3 lists the possible causes of this fault, including an airflow (DP) sensor error, a stuck or failed damper or damper actuator, low static pressure in the supply air duct, a scheduling conflict with the AHU, an undersized VAV box, a tuning problem with the airflow control PID loop, a maximum airflow setpoint that is too high, and a sequencing logic error. Onsite personnel investigated and determined that the fault was due to low static pressure in the supply air duct caused by an undersized supply fan in the AHU that serves this VAV box. Figure 5.24 illustrates that early and again later in the day, the airflow rate setpoint was at the minimum and the supply fan was able to maintain sufficient static pressure. When the airflow setpoint increased in the middle of the day, the actual airflow fell below the setpoint as the supply fan was not able to maintain the static pressure at the setpoint. The problem was corrected by replacing the sheaves on the supply fan and motor to increase the fan speed.

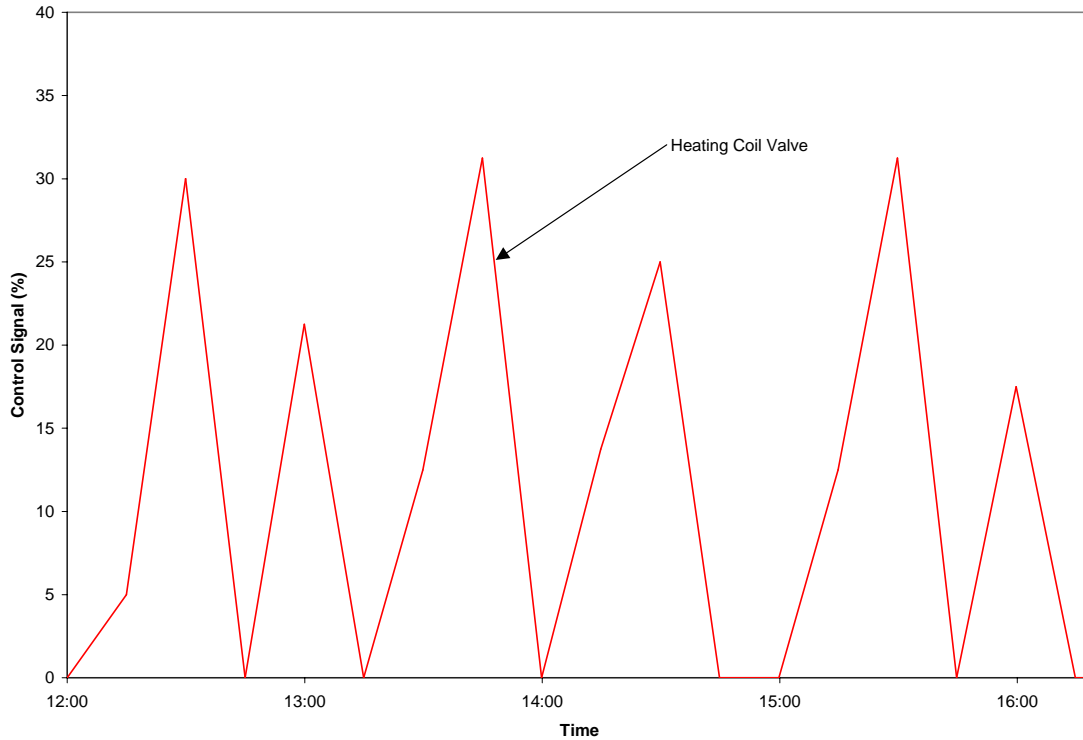
**Figure 5.25. SITE-7 AHU PID Loop Tuning Error.**

Figure 5.25 shows a plot of control signal data from one of the AHUs at SITE-7. Both stages of DX cooling remain off (not shown) and the economizer is positioned for minimum outdoor air (not shown), while the heating coil valve repeatedly cycles open and closed. The actual rate of valve cycling was observed by the researcher and the maintenance staff to be several times greater than that shown on Figure 5.25. An aliasing effect is present due to the relatively large trendlog sample interval time of 15 min. Whenever the heating coil valve is closed, the AHU is in Mode 5 (unknown mode of operation) and when the heating coil valve is open, the AHU is in Mode 1 (heating). Rule 28, which applies to all modes of operation, counts the number of mode switches per hour. If the count exceeds the threshold (seven mode switches per hour) then a fault has occurred. Although it does not appear so in Figure 5.2, Rule 28 is violated several times on the day shown. A trendlog showed that the APAR algorithm embedded in the AHU controller had generated several fault reports due to Rule 28. As shown in Table 2.2, the possible causes of this fault are a controller or logic error. Onsite personnel investigated and determined that the fault was due to the value of the parameters used to sequence the heating coil valve, stages of DX cooling, and the economizer.
