Final Report

Field Test DELTA Evaluation:
Occu-smart Light Fixture
Project A70913

Submitted to
LaMar Lighting, Farmingdale, NY

Submitted by
Lighting Research Center
Rensselaer Polytechnic Institute

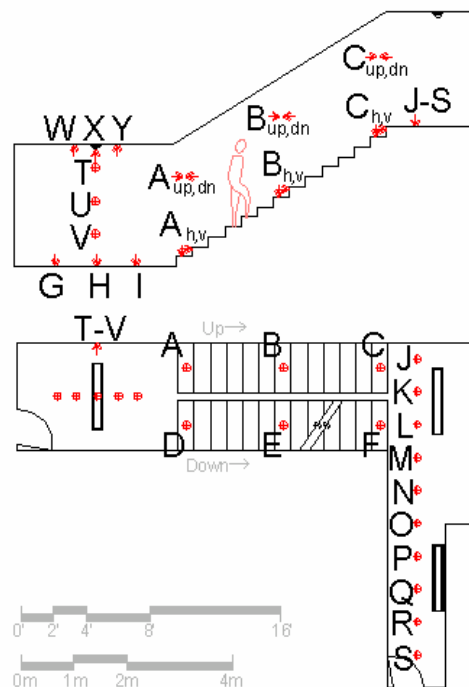
Figure 7: Measurement locations, typical Rivercross staircase

h = horizontal illuminance, measured in center of stair tread. Parentheses indicate darkest spot of tread

v = vertical illuminance on vertical face of tread (upward)

up = vertical illuminance at the eye, facing the upward direction

down = vertical illuminance at the eye, facing the downward direction

As shown in Table 1 and Figure 7 (page 9), illuminances at the full output setting increased 2-10 times with the new lighting. This is partly due to new T8 lamps with little lumen depreciation and higher mean lumen output. But much of the increased illuminances in the stairs are due to increased optical efficiency of the Occu-smart unit, compared with the old lighting. The lamps are not mounted deep within the recess of the fixture, but rather are wrapped by a diffuser lens (see Figure 4).

Illuminance (lux)		Illuminance (lux)		
		In Staircase		On Landings		
		Before	After	Before	After	
A	h	65	174 (152)	G	116	208
	v	44	128	H	139	245
	up	4	32	I	108	247
	down	98	328	J	110	215
B	h	12 (3)	60 (34)	K	109	251
	v	7	74	L	114	246
	up	9	52	M	98	197
	down	3	12	N	84	176
C	h	52 (2)	128 (13)	O	88	195
	v	3	21 (17)	P	116	243
	up	58	270	Q	152	271
	down	3	16	R	122	239
D	h	41 (2)	107 (12)	S	80	173
	v	2	20			
	up	24	240			
	down	2	15			
E	h	11 (4)	63 (36)	Luminance (cd/m²)		
	v	9	73	Before	After	
	up	8	65	T	15	36
	down	3	11	U	14	27
F	h	66 (55)	145	V	9	18
	v	42	124	W*	2	30
	up	4	28	X*	1310	5000
	down	37	296	Y*	3	27

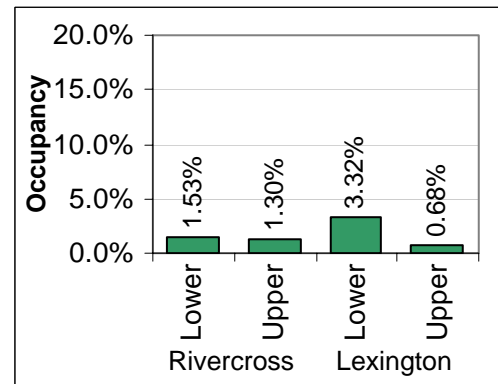
Figure 20: Occupancy Rates

Watt Stopper IntelliTimer® light loggers were installed (by others) in both projects to estimate typical occupancy percentages. As expected, occupancy percentages were found to be very low in both projects (see Figure 20, right). Lower floors had higher occupancy, and thus were separated in the analysis for increased accuracy.

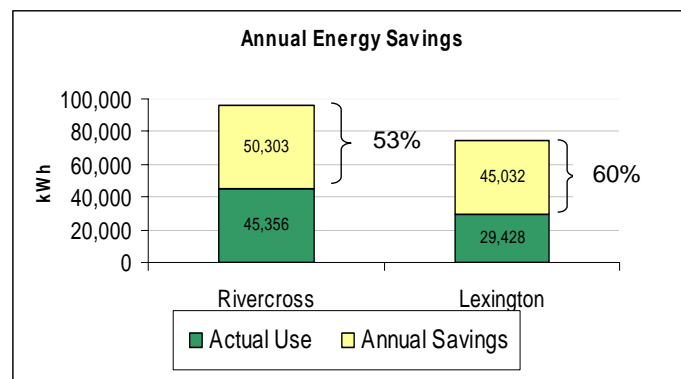
Figure 21: Annual Energy Savings

By these estimates, the installation at Rivercross is annually saving 50,303 kWh or 53%. Assuming a conservative 50% demand reduction, these savings translate to \$4,741 per year, or a 4.9 year simple payback (see Appendix 6). If emergency battery packs had not been required, payback would have shortened to 2.6 yrs.

The installation at Lexington is annually saving 45,032 kWh or 60%. Assuming a conservative 50% demand reduction, these savings translate to \$5,916 per year, or a 5.0 year simple payback.

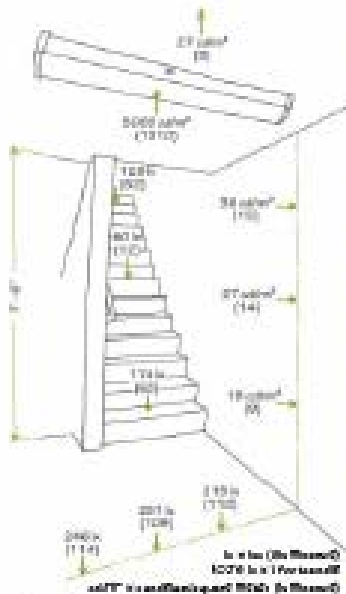
Perspective showing photometric conditions at full output in typical Rivercross staircase (measurements of previous lighting shown in parentheses); for standby levels, divide values by 3
